INVESTIGATING OF PITTING FORMATION ON GEAR TOOTH AND EVALUATING LIFE TIME OF GEARS USING SEM

Kalathur Kumar¹, Dr.S.Arul², Dr.G.Sriram³, Dr.V.N.Mani⁴, V.Prathap Kumar⁵

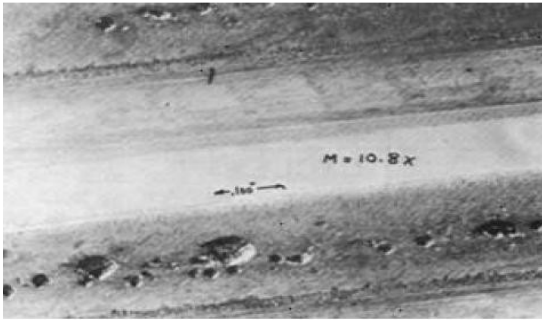
Figure.1: Pitting Action on Gear Tooth.

Extensive pitting, spalling and surface cracking can be seen at the crack origin in Fig. 1. In addition, scoring marks along the circumference of the web can also be seen. A proper sample piece was cut from the gear close to the crack origin. The cracked surface of the failed spur gear was examined in a scanning electron microscope to identify the cause of fatigue crack initiation.

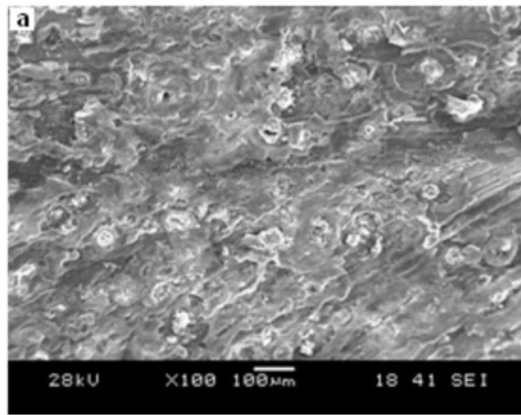
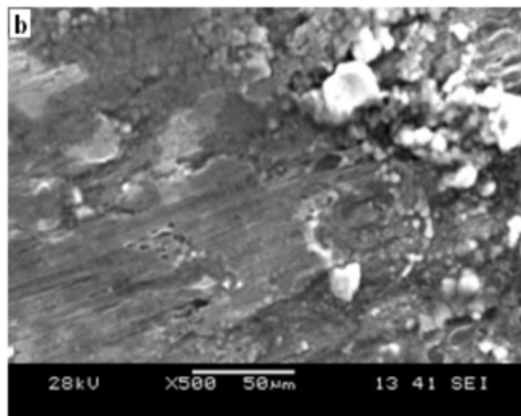
During the inspection of the gearbox, 21 out of 25 from the gear found to be damaged. The crack surfaces of gear teeth were examined by using SEM is shown in Fig. 4. SEM examinations by using secondary electron imaging technique make visible by uncovering the crack surface of the sun gear teeth. The presence of microscopic fatigue grooves at higher magnifications showed the [18,19] growth of fatigue cracks which are reliable with mechanical fatigue failure of the sun gear teeth which are subjected to severe kind of fatigue loading. A recent study showed that majority of service failures in sun gear occur by fatigue and gear loading is critically vital fact.

Figure 4(a, b). SEM showing the fatigue crack originated by micro crack

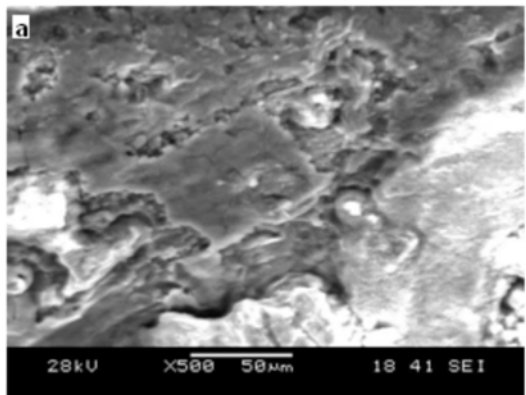
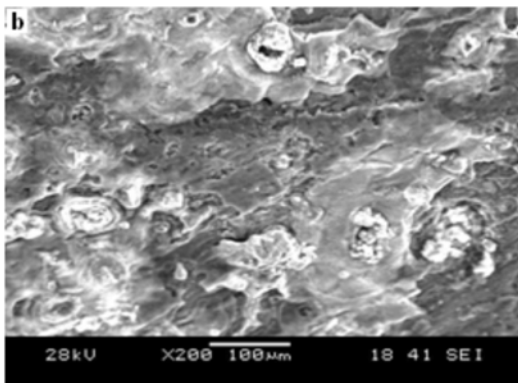
Figure 6. (a, b) SEM showing the pitting at the magnification

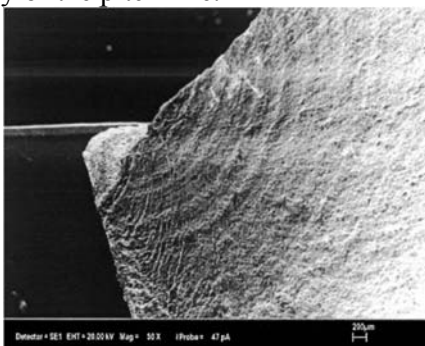
Figure 7. SEM micrograph showing the crack initiation and propagation region.

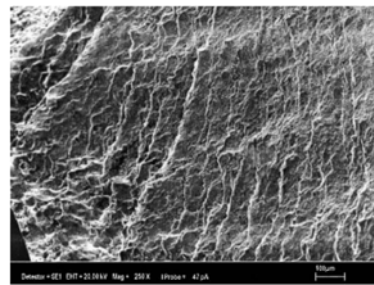
Figure 8. SEM micrograph showing typical brittle fracture observed in the crack propagation region.

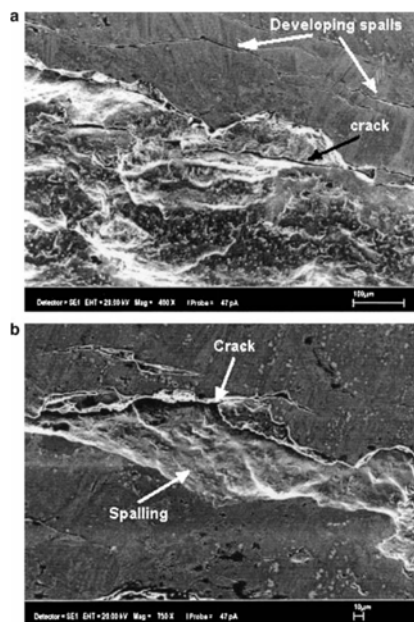
Figure 9. SEM micrograph showing two damaged area at the pitch line at the different magnification.
